Quantico Creek Watershed Assessment Report

Prepared for:
Prince William County
Department of Public Works
Watershed Management Branch
5 County Complex Court, Suite 170
Prince William, Virginia 22192

Prepared by:
MACTEC Engineering and Consulting, Inc.
21740 Beaumeade Circle, Suite 150
Ashburn, Virginia 20147

April 2011

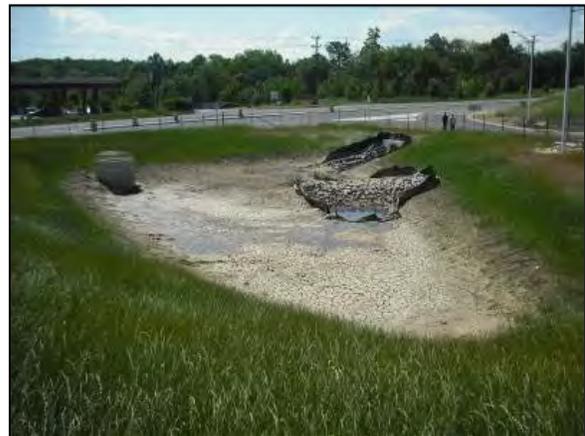
Figure 3-9: Existing Stormwater Basin With No Permanent Pool and Lack of Internal Structure.

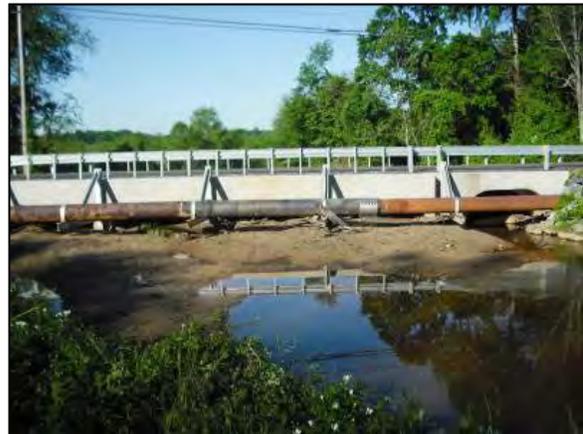
Figure 4-4: Deposition of sediment at Possum Point Road culvert, Reach 630-A.

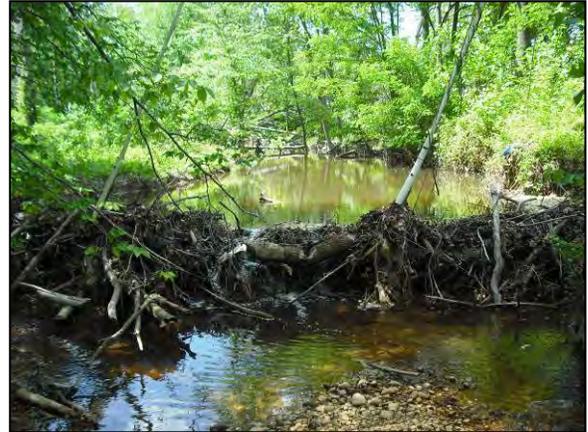
Figure 4-5: Large woody debris jam responsible for localized bank erosion, Reach 630-B.

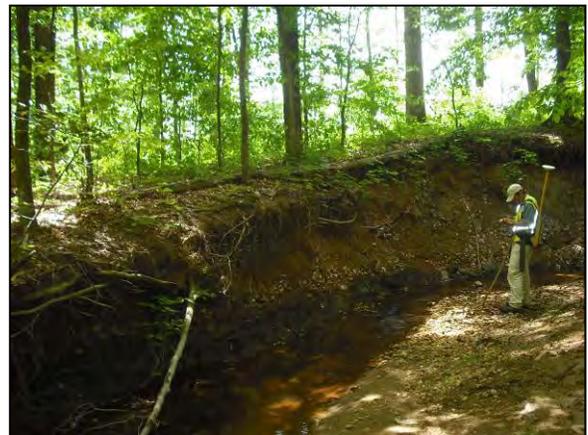
Figure 4-6: Localized bank erosion occurring adjacent to deposition of coarse gravel, Reach 630-C.

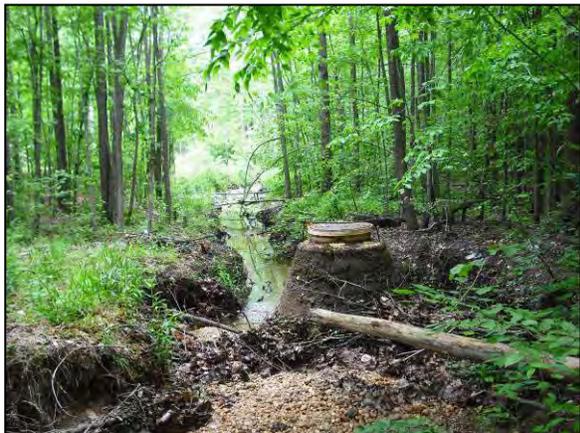
Figure 4-7: Systemic erosion has exposed a sewer line, parallel to the stream, along Reach 630-D.

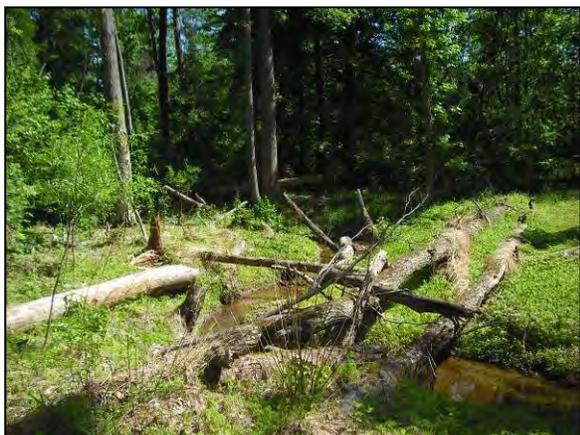
Figure 4-8: Moderate channel incision, slowed by *de facto* grade control, Reach 630-F.

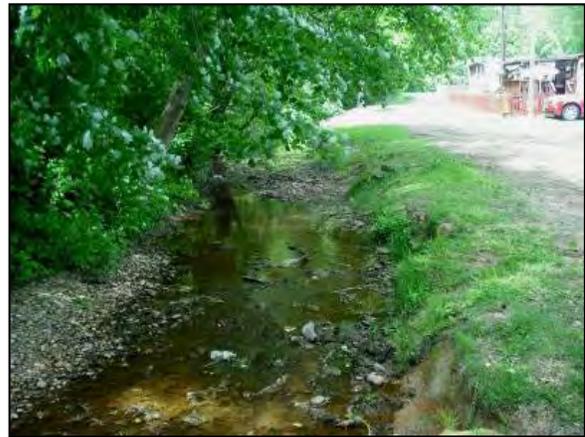
Figure 4-10: Removal of riparian forest along Creek Road, Reach 645-A.

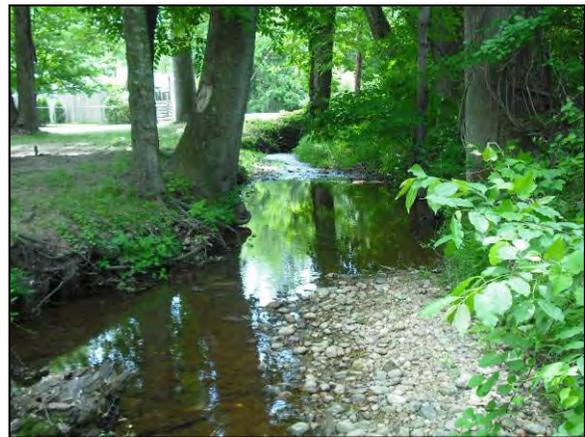
Figure 4-11: Removal of riparian forest and encroachment on the stream corridor, Reach 645-B.

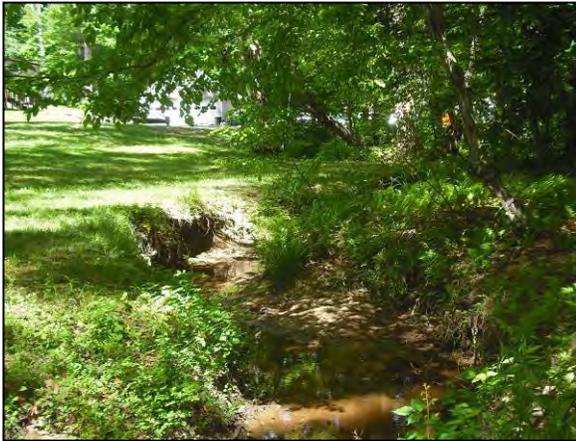
Figure 4-12: Removal of riparian forest and mowing to the top of bank, Reach 645-C.

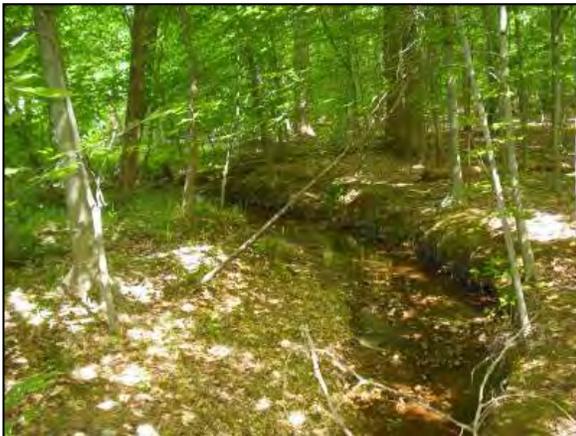
Figure 4-13: Moderate channel incision near Park Entrance Road, Reach 645-D.

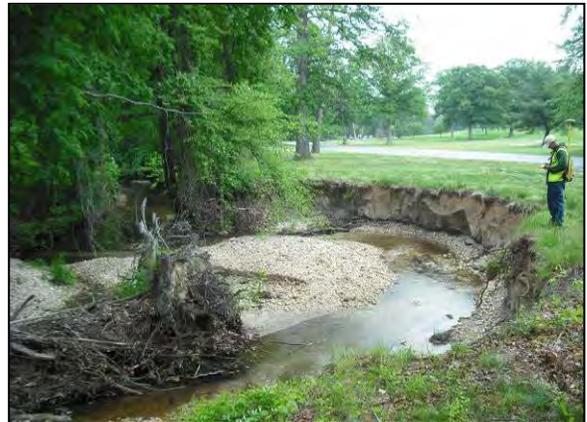
Figure 4-15: Channel widening and streambank erosion near Fuller Road, Reach 650-A.

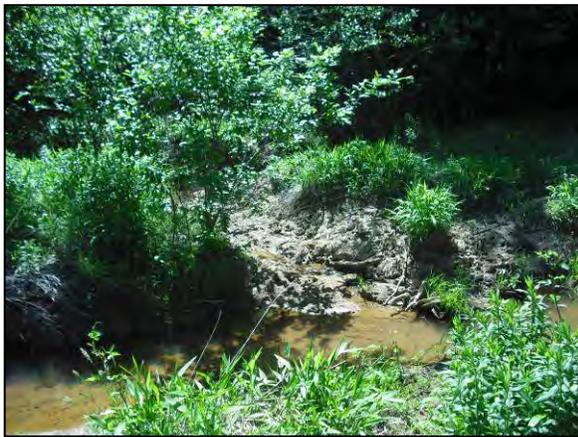
Figure 4-17: Channel incision and erosion near Crystal Downs Terrace, Reach 665-A.

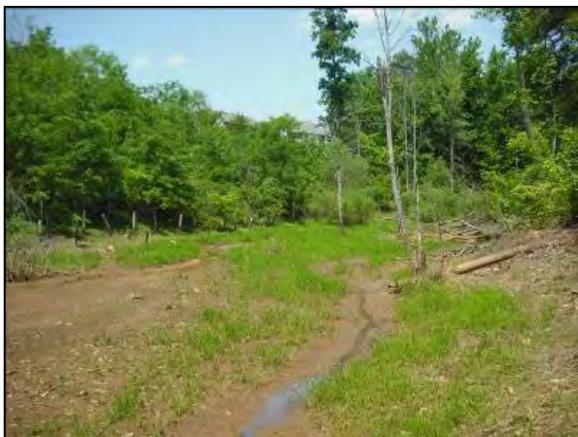
Figure 4-18: Sedimentation of inline basin, east of Oyster Bay Court, Reach 665-B.

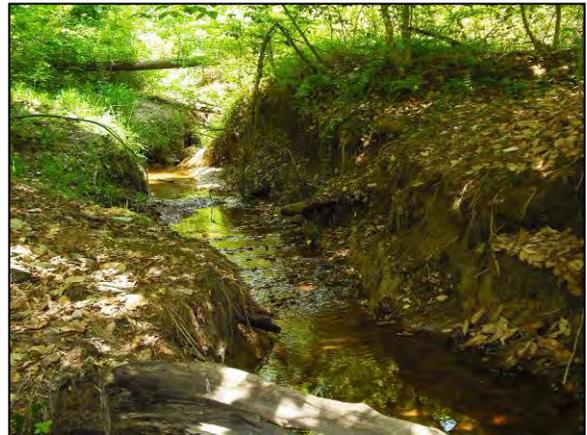
Figure 4-19: Channel incision and woody debris, near Myrtlewood Drive, Reach 665-C.

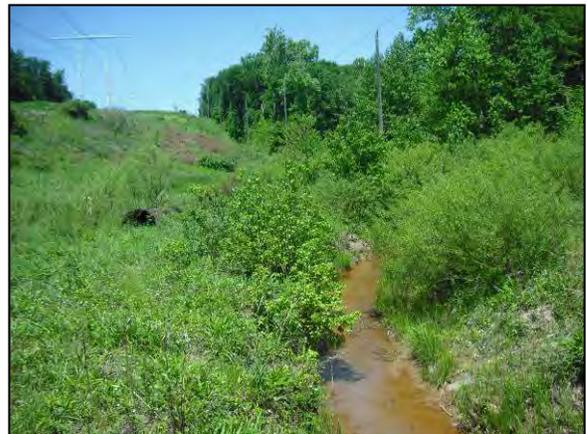
Figure 4-20: Removal of riparian forest underneath the power lines, along Reach 665-D.

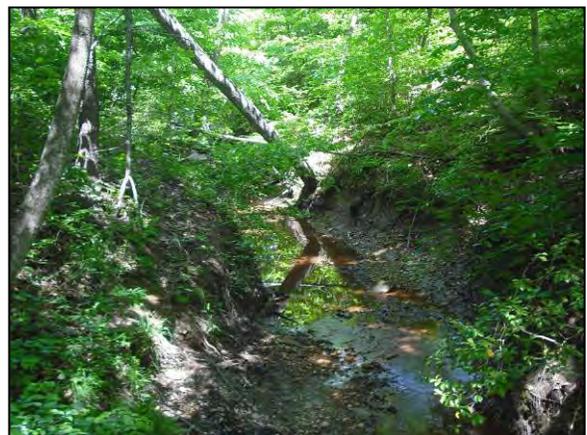
Figure 4-21: Moderate channel incision, slowed by de facto grade control, Reach 665-E.

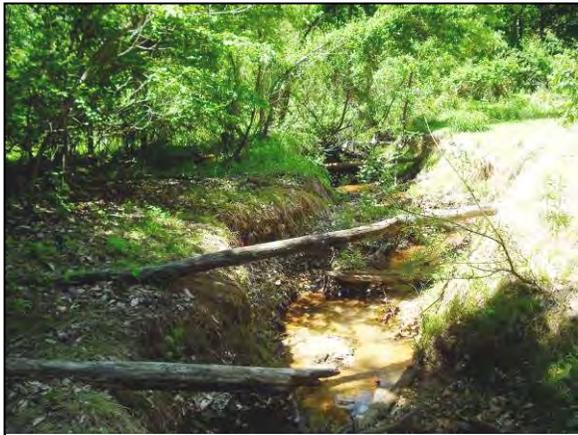
Figure 4-22: Channel incision and erosion downstream from Medford Drive, Reach 665-F.

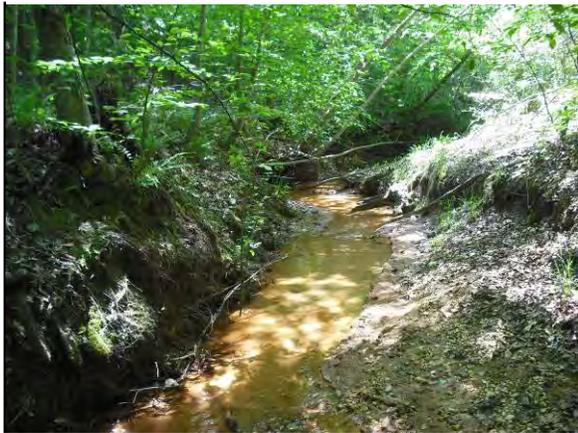
Figure 4-23: Deposition and channel widening, from Myrtlewood to Medford Drive, Reach 665-G.

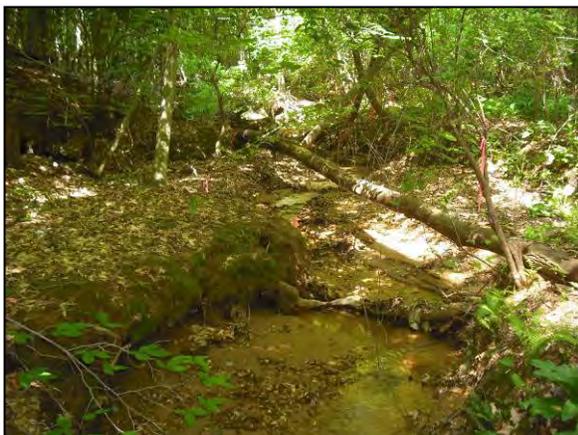
Figure 4-24: Deposition and channel widening, upstream from Myrtlewood Drive, Reach 665-H.

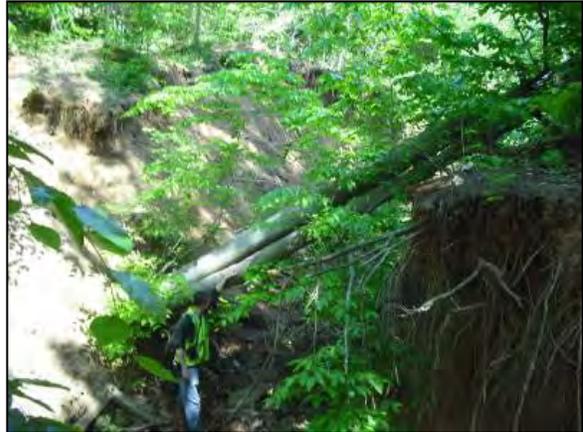
Figure 4-25: Severe channel incision and imminent loss of property, Reach 665-I.

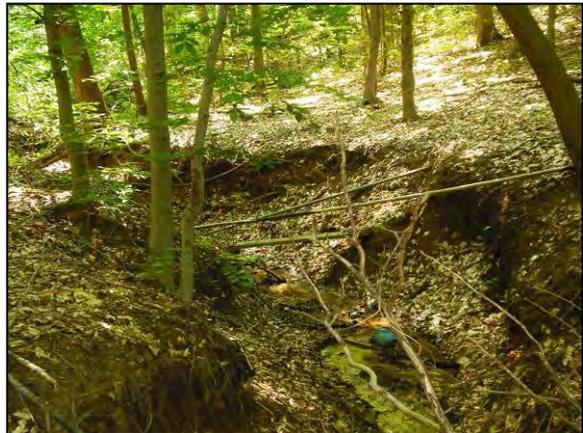
Figure 4-26: Severe channel incision and erosion, downstream of River Heritage Boulevard, Reach 665-J.

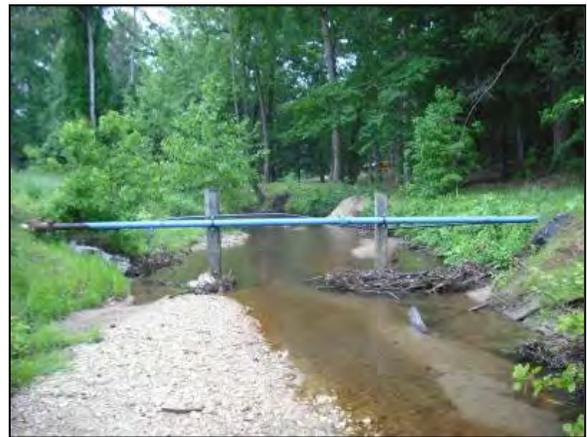
Figure 4-28: Channel widening near the Medal of Honor Golf Course, Reach 690-A.

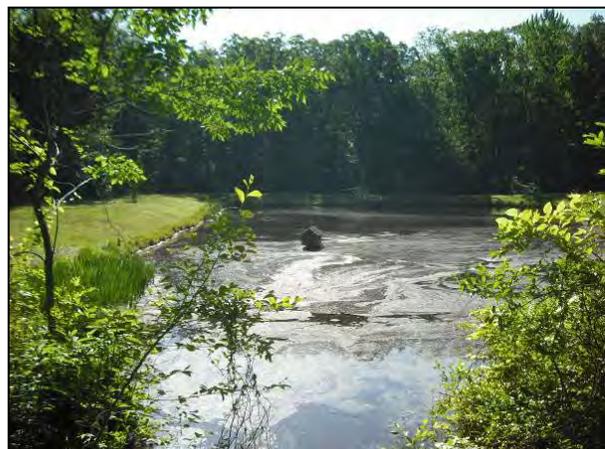
Figure 4-31: Excessive algae growth, indicative of nutrient loading and eutrophication at FAC-473.

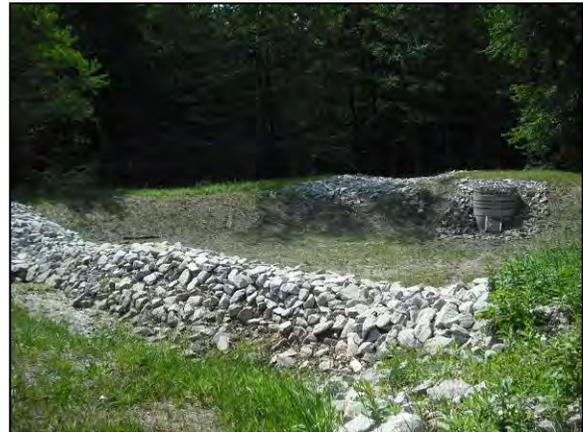
Figure 4-35: Dry basin lacking internal structure, microtopography and vegetation, FAC-5379

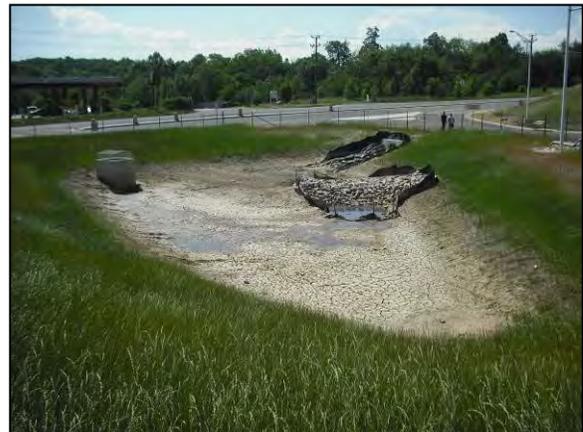
Figure 4-36: Newly constructed pond, with no permanent pool, and short flow path, FAC-5463

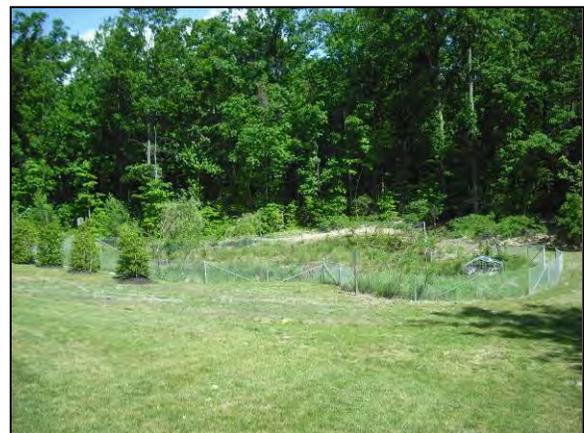
Figure 4-37: Vegetated basin, lacking internal structure and microtopography, FAC-5515.

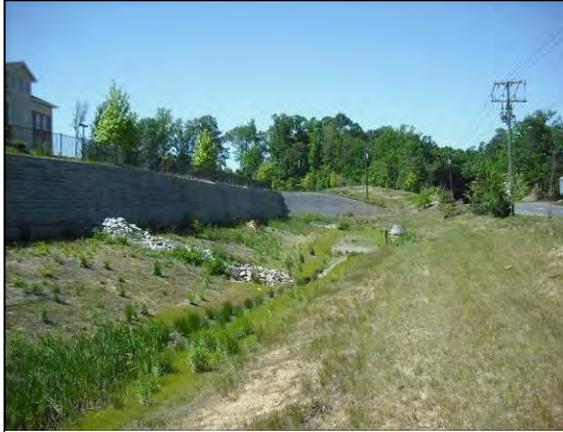
Figure 4-38: Vegetated swale/dry basin experiencing rill and gully erosion, FAC-5122.

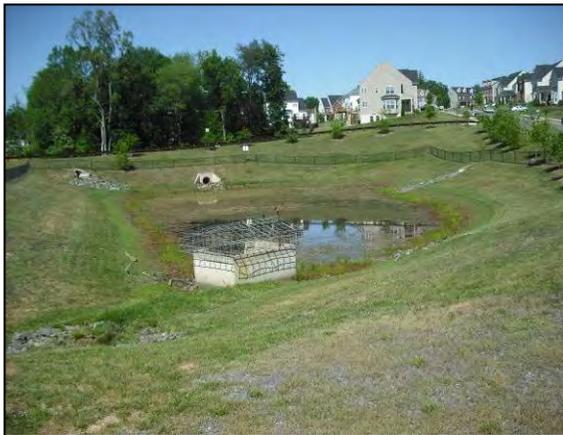
Figure 4-39: Wet pond in lacking forebay, microtopography, and vegetation, FAC-669.

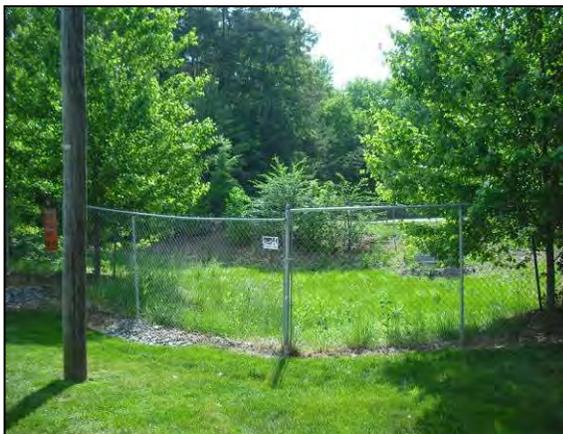
Figure 4-40: Well-vegetated extended detention basin, with short flow path, FAC-5397.

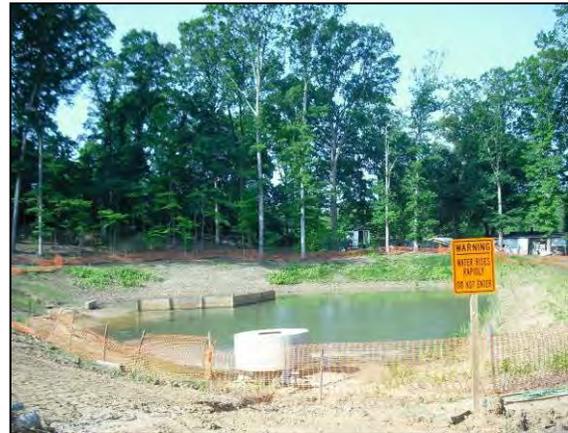
Figure 4-41: Newly constructed pond, lacking forebay and vegetation, FAC-5000.

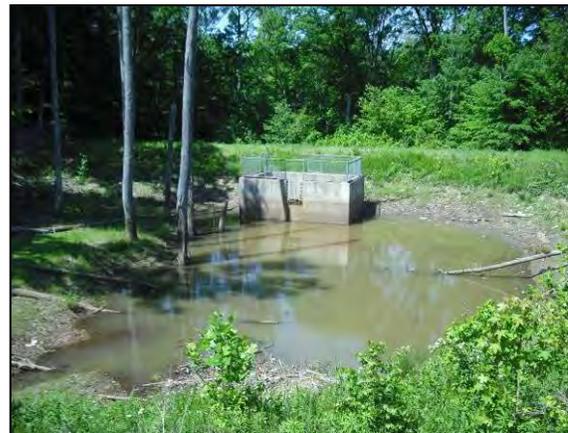
Figure 4-42: Wet pond lacking forebay, with adjacent forest cover, FAC-533.

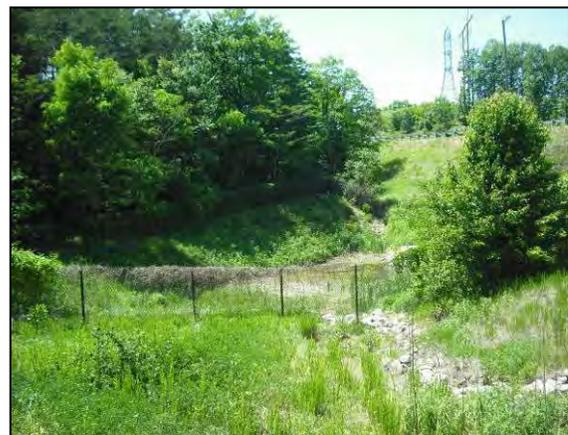
Figure 4-43: Steep gradient, riprap swales leading to the existing wet pond, FAC-5462.

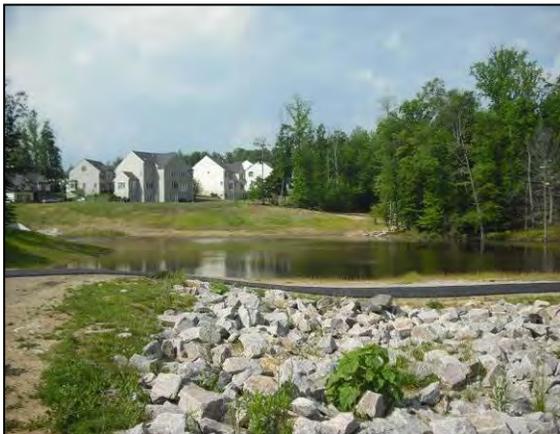
Figure 4-46: Pond with adequate storage capacity, lacking native vegetation, FAC-9025.

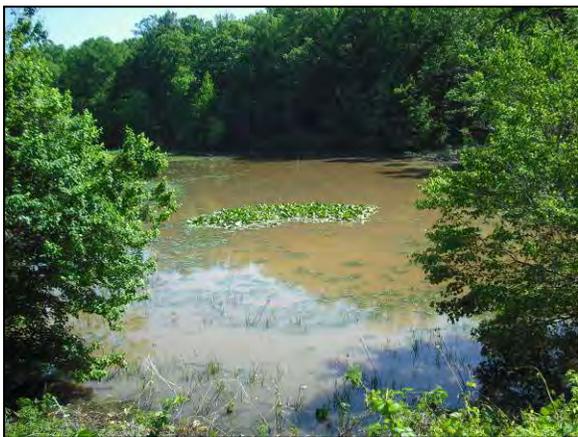
Figure 5-1: Silt-laden backwater and invasive vegetation near the mouth of Quantico Bay.
