Williams-Dawe House

Community Meeting

SWSG, PC

June 18, 2025

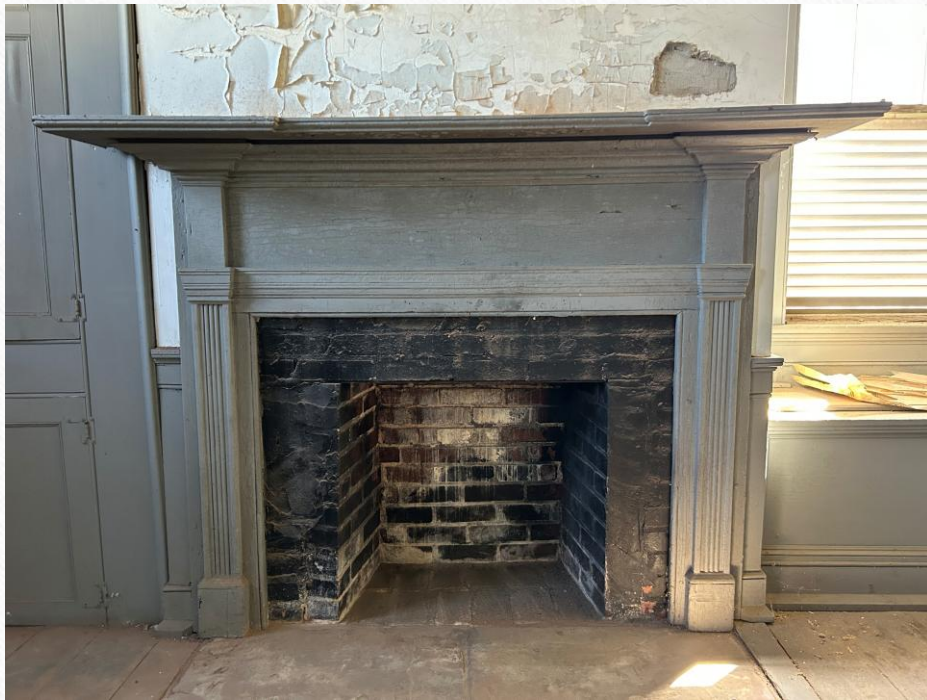
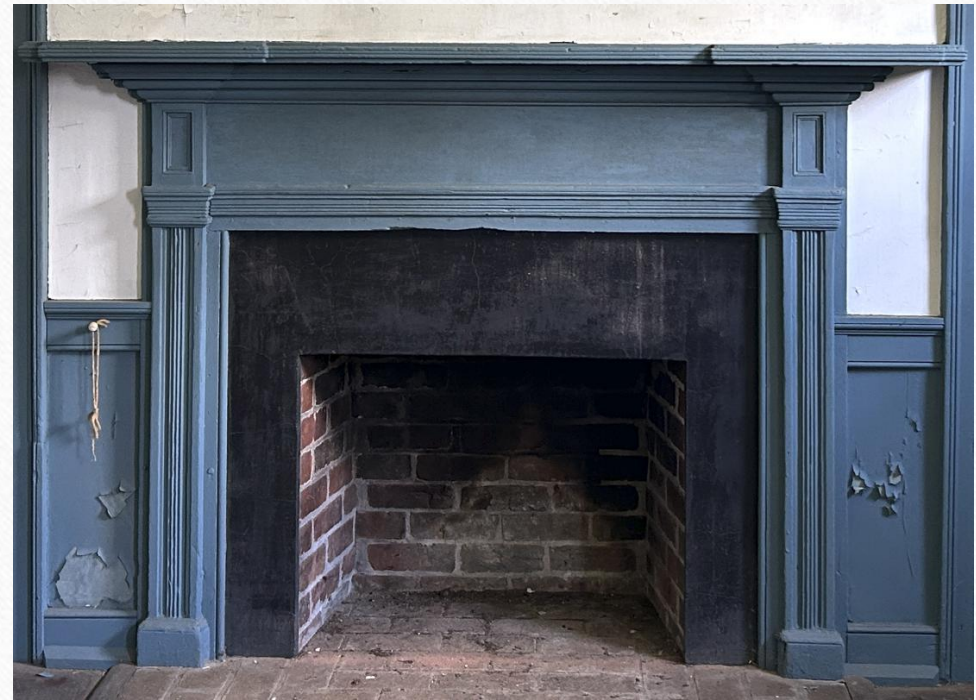
Original Materials – Mantlepieces

Ca. 1823

Ca. 1827

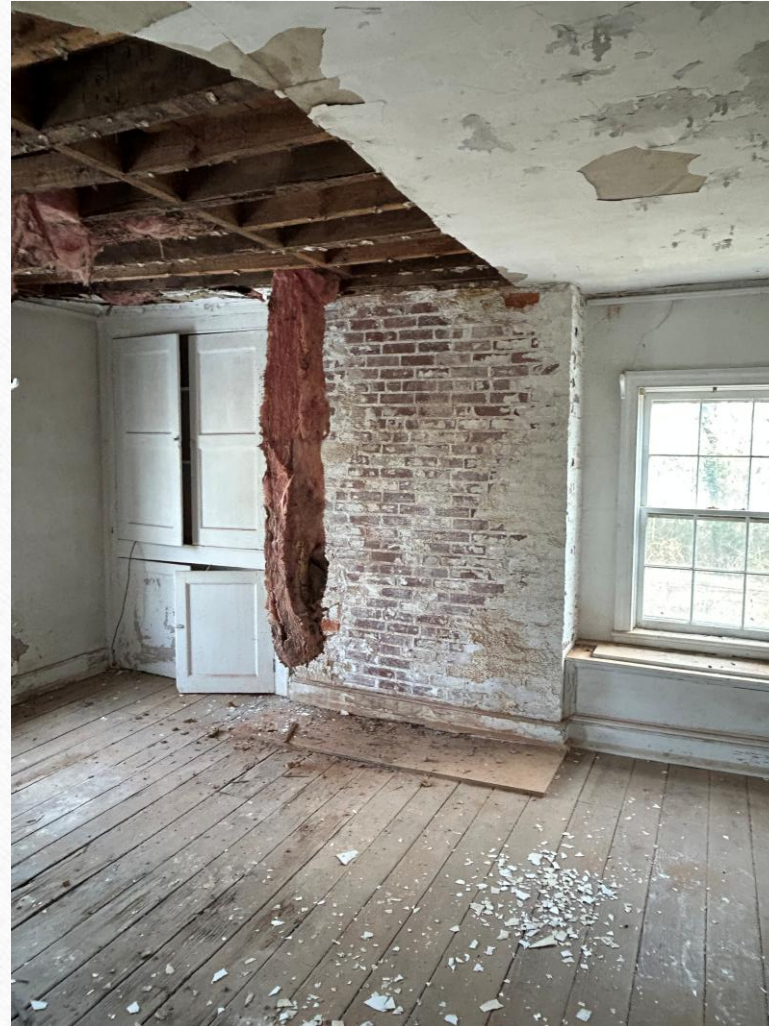
Cellar Fireplace / Second Floor Fireplace

- Clues
 - Only two flues
 - Bedroom firebox infilled
 - Second floor bedroom hearth

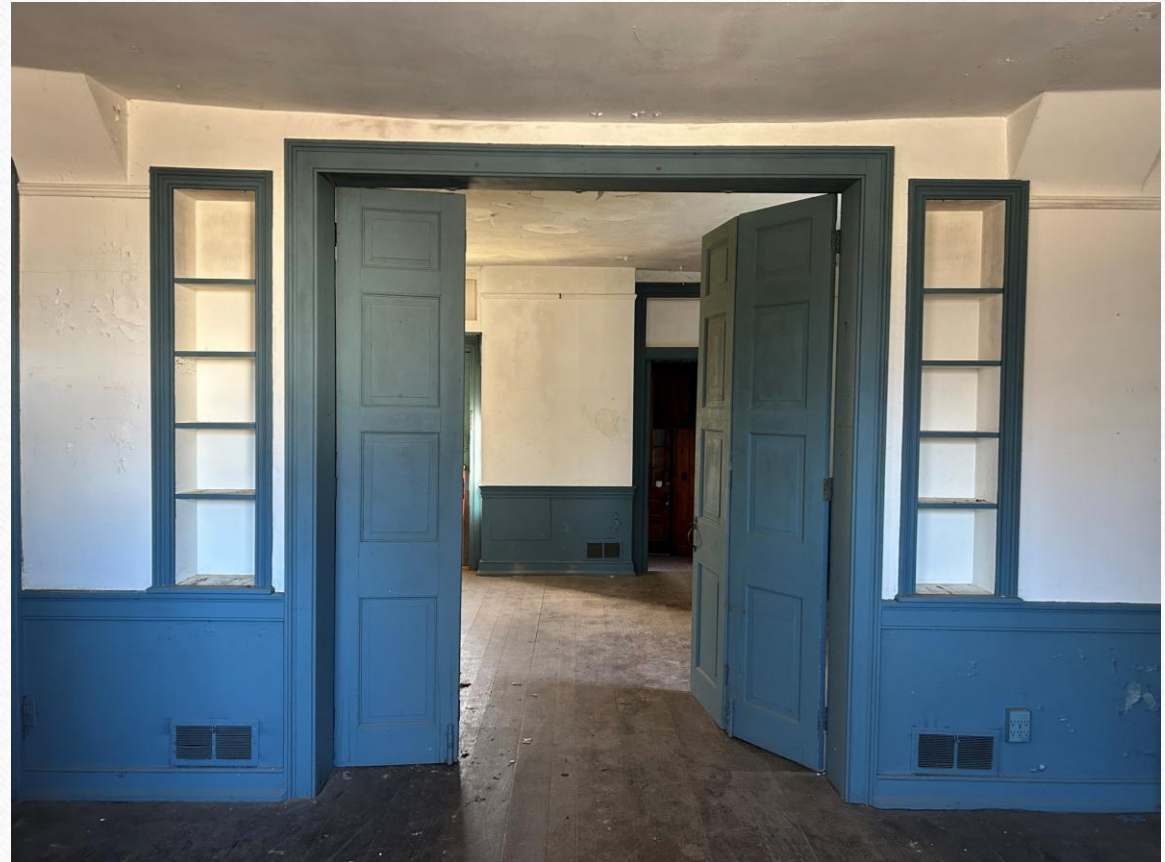
Structural Issues

Removal of large portions of load-bearing walls

South wall foundation deterioration

Masonry bulge due to ductwork installation

Roof support

Floors are 65 psf of live load.
