# Powells Creek Watershed Management Plan

June 2008

Prepared by:  
Michael Baker Corporation  
9400 Innovation Drive, Suite 110  
Manassas, VA 20110

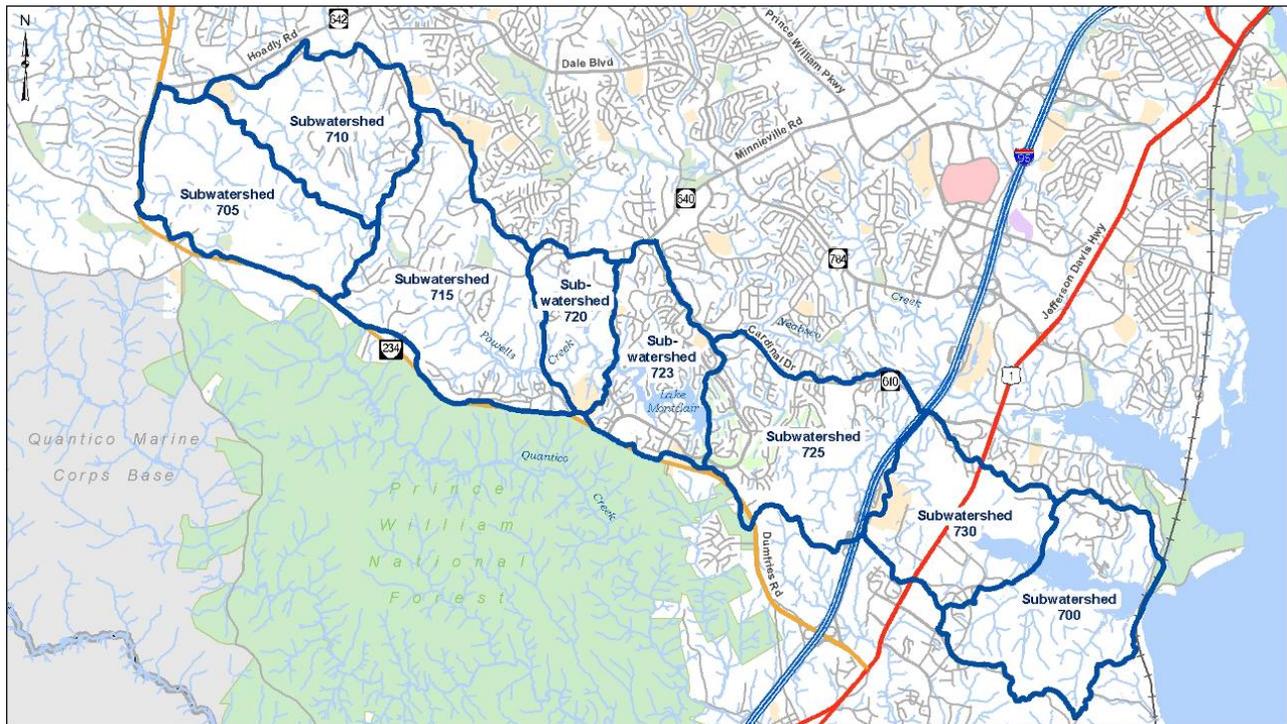
FIG 1: Powells Creek Watershed with Subwatersheds

The Powells Creek Watershed covers approximately 11,500 acres (18 mi<sup>2</sup>) draining to the Potomac River along the southeast boundary of the County. The watershed is long and narrow, which affects the drainage characteristics, with a typical width of just 1.5 miles. The watershed has previously been broken into eight subwatersheds for the purpose of refining the drainage area influences.

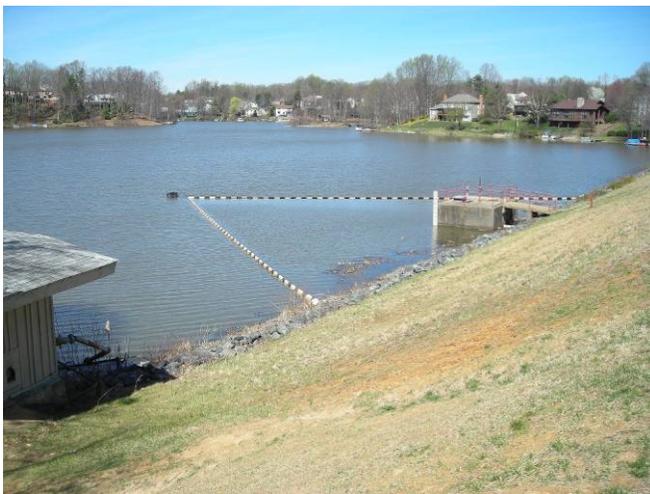
**FIG 2: Outfall structure at the Lake Montclair Dam**

The Community of Montclair was established in 1968, and home building was mostly completed by the early 1990's. Because of its position in the watershed, Lake Montclair serves as a sediment sink for the upper half of the watershed. According to the Montclair Property Owners Association's web site, the association spent around \$900,000 in 2007 to dredge the lake. The Association budgets \$500,000 for the lake to be

The 1989 Hydraulic report pointed out that Lake Montclair provides primary flood mitigation for the Powells Creek Watershed. There are no known plans for the construction of Lake Montclair, formerly known as Country Club Lake, which was built in 1963-1964 with a top elevation of 200 ft (NGVD). In 1970, the dam was raised by 6.5 feet, with improvements being made to the principal and emergency spillway (although no mention was made to changes in elevation for either). At the time of the Hydraulic study, the dam was being further modified per the recommendations of the 1978 US Army Corps of Engineers Phase I report to turn ownership over to the Montclair Homeowners Association, which is still the responsible party for the facility. The permanent pool elevation for Lake Montclair was reported to be 188 feet (NGVD) with the emergency spillway invert set at 193 feet (NGVD).

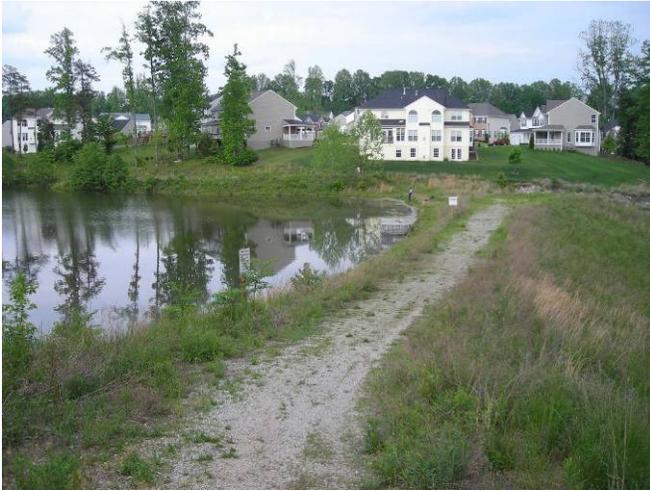
**FIG 3:** The embankment and outlet structure for Lake Terrapin

Due to the presence of regional lakes such as Lake Montclair and Lake Terrapin, the center of the Powells Creek watershed holds the key to the overall hydrologic response of Powells Creek. Another significant factor is the percent of higher density residential development that exists, much of which has little or no distributed stormwater management in place. This includes

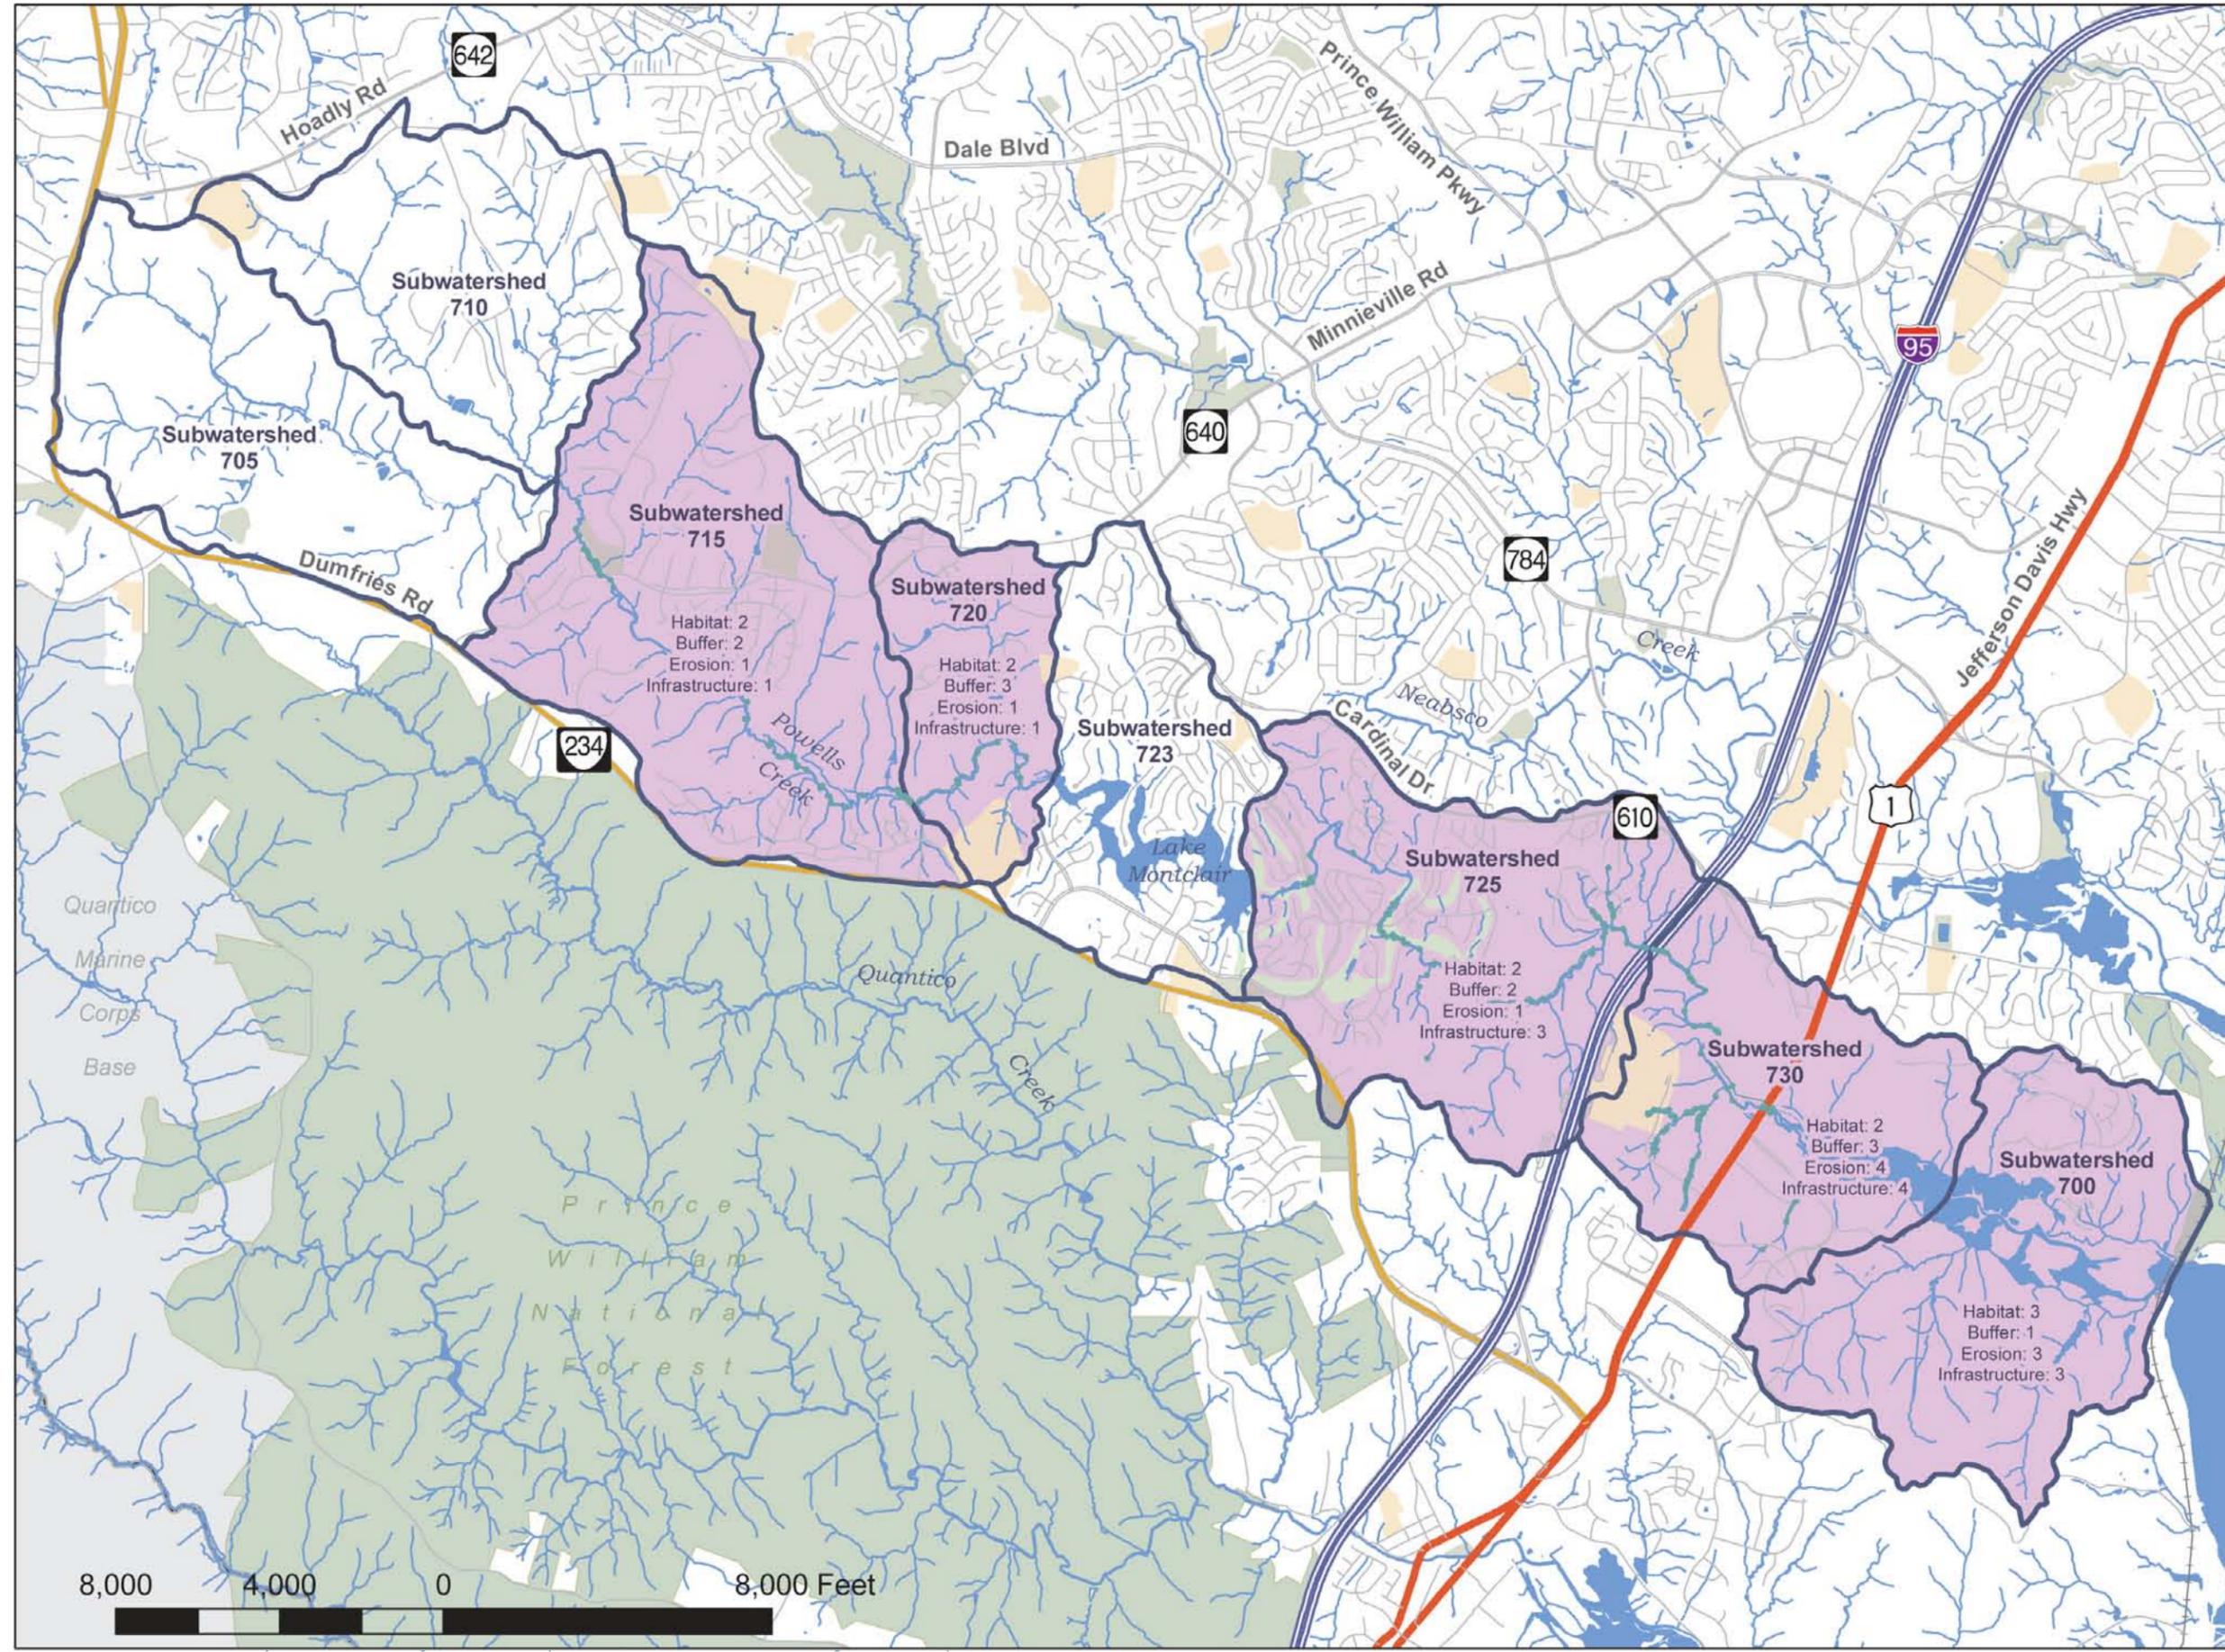
Data collected were entered into a database and digitized into a GIS-based Stream Assessment Tool, which is now available online at [www.pwcgov.com](http://www.pwcgov.com). Using a scoring system of 0 to 200, with 200 being the best and broken into categories of: Optimal (160-200), Suboptimal (107-159), Marginal (55-106) and Poor (0-54), Powells Creek scored 129, rating it as sub-optimal overall. Of the linear feet of stream assessed, 60,560 LF were rated as suboptimal and 7,130 LF were rated marginal. It should be noted that the overall score of 129 tied Powells Creek with Bull Run for the highest habitat score in the County, and the length weighted score for the County as a whole was 119. It should also be noted that the Stream Assessment study did not evaluate or consider streams in either of the headwater subwatersheds (705 and 710) or in subwatershed 723.

- Inventory Point
- ~ Inventory Line
- Subwatershed
- Waterbody
- ~ Stream
- Inventoried Watersheds

**Inventory Ratings**  
 1=Optimal  
 2=Suboptimal  
 3=Marginal  
 4=Poor

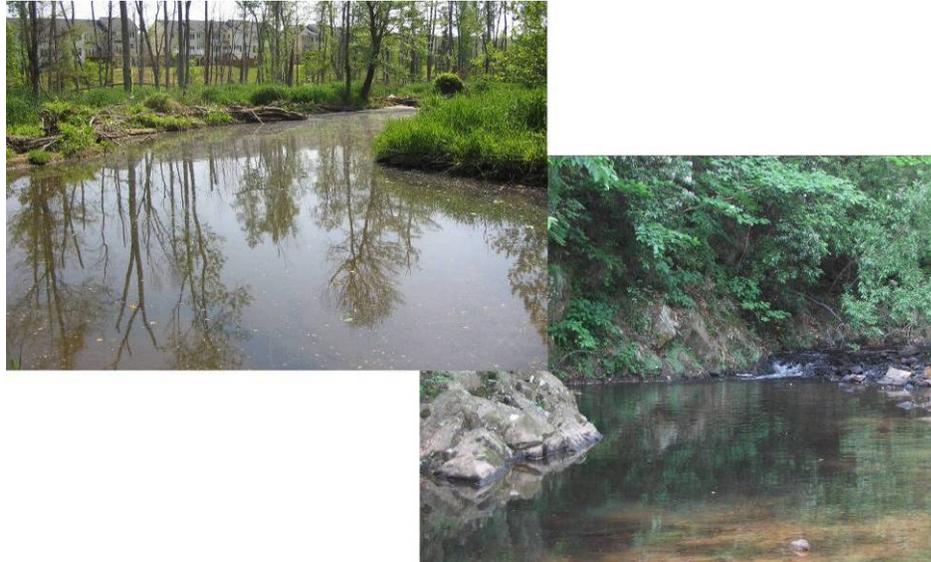
“The topography of the watershed is characterized by steep slopes and ravines that drain to the Powells Creek channel. The Powells Creek channel is a defined channel eroded to bedrock in places and has an average longitudinal slope of 0.3 percent. Below U.S. Route 1, the Powells Creek channel is a flat marshy wetland area until it flows into the tidal Potomac River.”

**FIG 5:** At left is a photo below US Route 1, where Powells Creek is a braided stream consisting of a wide floodplain and low gradient wetland. The photo on the right, taken below Lake Montclair shows the bedrock dominated stream above the fall line.

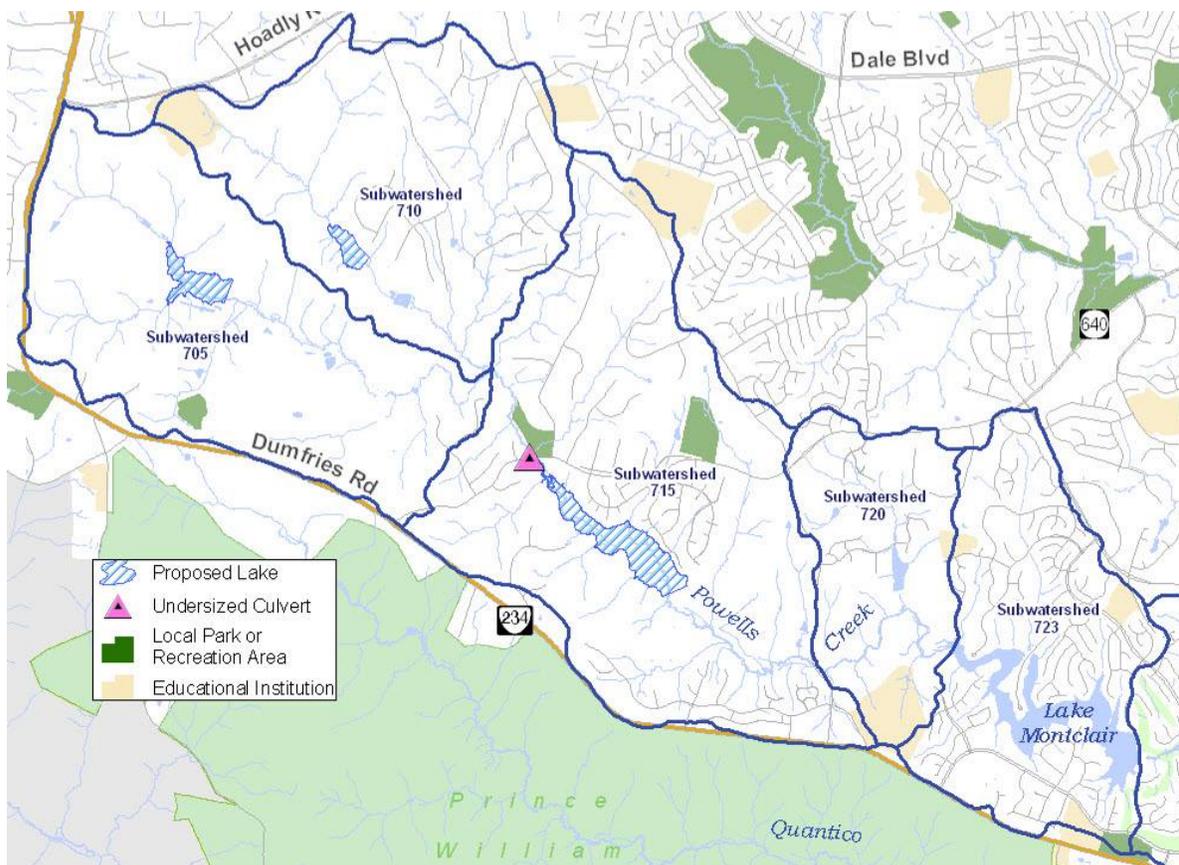
FIG 8: Upper Basin Recommendations from Hydraulic Study

and the construction of 3 major impoundments on the main stem of Powells Creek in the upper watershed.

2. Use regional facilities to address 10-year stormwater management requirement for the upper watershed, while strictly enforcing adequate outfall for the 2-year storm.
3. Provide BMPs (i.e. water quality treatment) on sites, to the degree possible, but encourage natural BMPs such as protection of undisturbed areas and leaving tributaries as natural as possible to provide natural storage, filtration of sediments and ensuring consistency of the time of concentration.
4. Redesign Route 640 (Minnieville Road) roadway and culverts to meet VDOT design conditions (is currently being pursued under County roadway project).
5. Implement channel bank stabilization projects for two 2000 LF reaches of Powells Creek: a) above Minnieville Road and b) immediately above Lake Montclair.

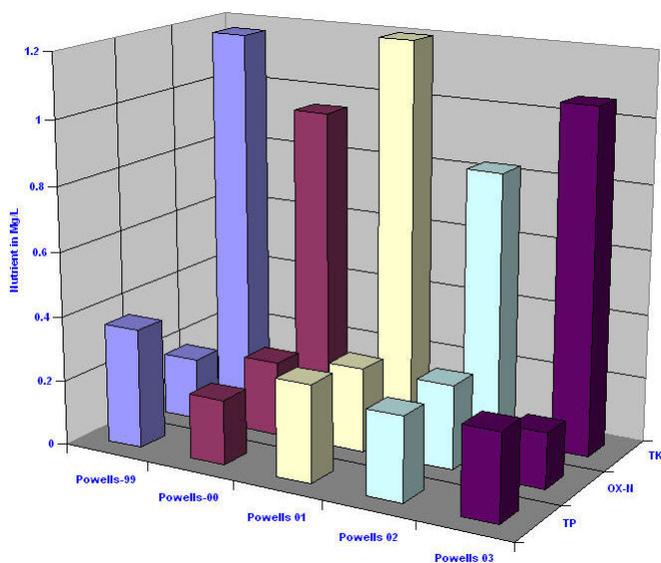
**FIG 9: Nutrient Concentration Comparison by Year at the Spriggs Road Monitoring Station**

- TSS data is highly variable depending on when the sample is taken, and in these instances was either in the range of the NURP Average or well above.
- TKN fluctuates with every sample taken, although most are substantially below NURP Averages.
- Nitrites and Nitrates are relatively constant in all samples reported...all of which were well below the NURP Average.
- Total Phosphorus samples are consistently reported to be near the NURP Average.

While NURP Averages may not provide a meaningful comparison, these values were reported in the available records and do provide some context with which to assess the relative presence of Suspended Solids and reported Nutrients from this location.

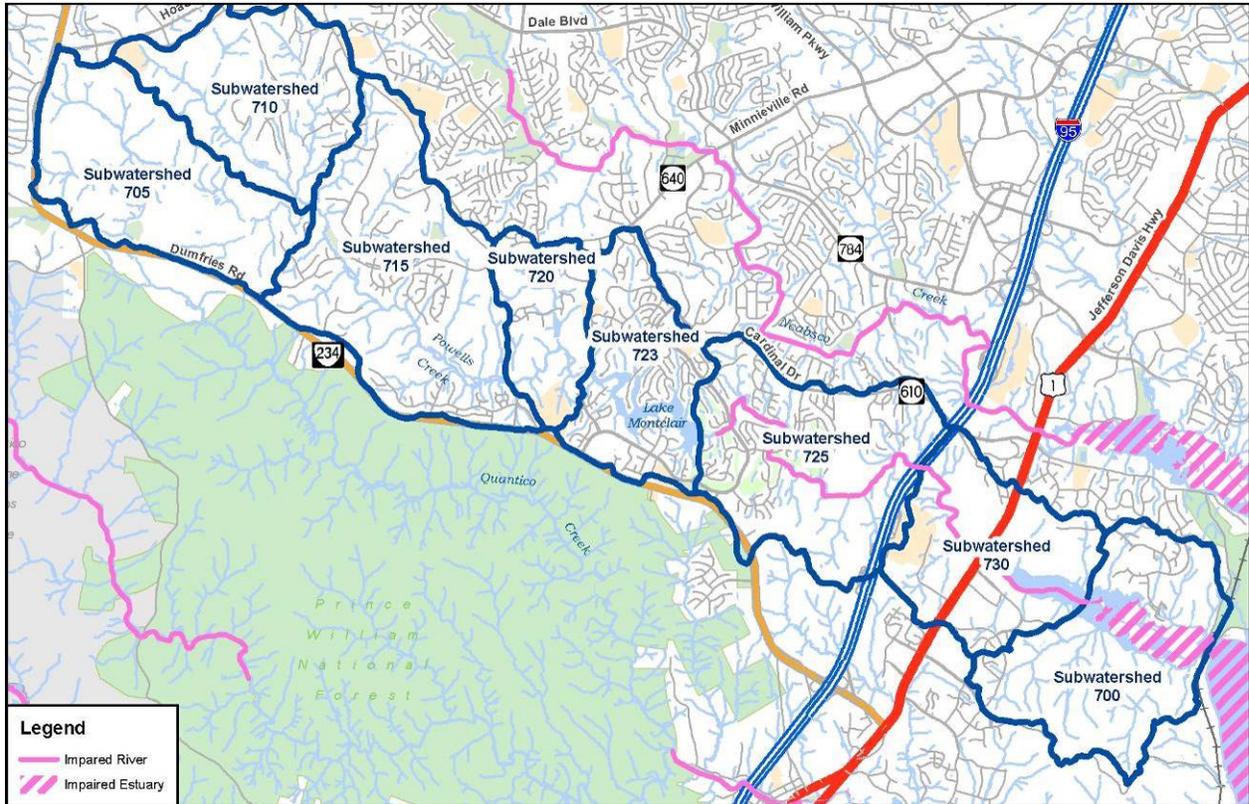
FIG 10: 2006 Impaired Water Bodies (Virginia DEQ)

The 2006 list of impaired waters included the entire section of Powells Creek below Lake Montclair. For regulatory purposes, this section is 5.02 miles and is scheduled to have a TMDL prepared in 2014. Impairments in this reach are Fecal Coliform, PCB and Benzo[k]flouranthene, based on ambient water quality monitoring and fish tissue/sediment monitoring at the Route 1 Bridge. While PCB and Benzo[k]flouranthene were initially listed in 2002, the fecal coliform listing is new for 2006.

It is generally thought that the PCB and Benzo[k]flouranthene reach into the Powells Creek watershed from the Potomac River where they are present. If this is the case, little can be done within this watershed, but caution and education on their presence is important to minimize potential human contamination. Fecal coliform bacteria impairments are becoming more widespread in urbanized communities throughout Virginia. The source of this bacteria is still widely speculated upon, but implementation plans may include expensive sewage system inspections and overhauls, pooper-scooper ordinances, leash laws or other means of reduction associated with the various sources of bacteria within our watersheds.

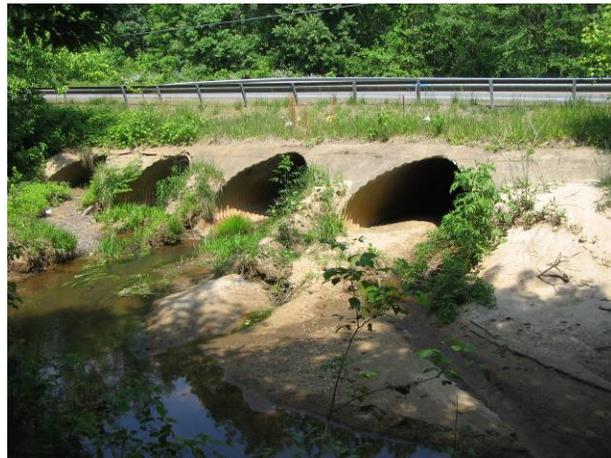
**FIG 11: Downstream face of culverts under Minnieville Road (Rt. 640)**

These were: Powells Creek at US Route 1, Powells Creek at Spriggs Road and Powells Creek at Minnieville Road. In each of these cases the culverts were deemed inadequate to convey the anticipated peak discharges as the watershed developed.

Spriggs Road has been upgraded in recent years and is therefore assumed to be capable of passing the design discharge associated with the road classification. US Route 1 does not appear to have been upgraded in recent years, but the Hydraulic Study determined that it

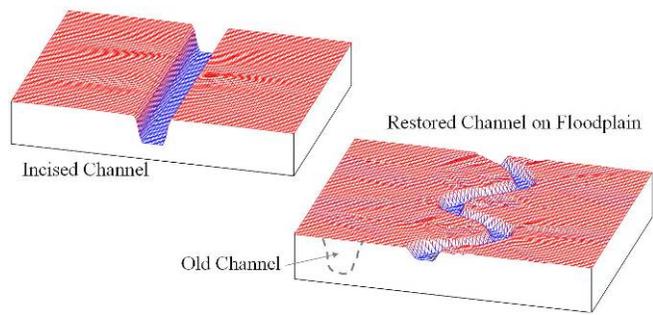
**FIG 12: Before and After Representations of a Priority Level 1 Stream Restoration**

Two categories of natural channel design approaches were recommended, and in some cases the recommendations were interchangeable. The first category is a Priority Level 1 stream restoration, in which the channel invert is brought up to the appropriate elevation such that flow appropriately reaches the overbanks/flood prone area. The second category is a Priority Level 2 stream restoration, in which the floodplain is brought down to the appropriate elevation relative to the existing channel invert.

The primary issue to consider when determining which approach to use is that a Priority Level 1 approach typically requires less earthwork (i.e. less costly), but often raises flood water to an unacceptable elevation. On the other hand, the Priority Level 2 approach can be used to reduce flood elevations and provide additional storage, but costs associated with hauling earth material can be prohibitive, unless there is a location close to the project site.

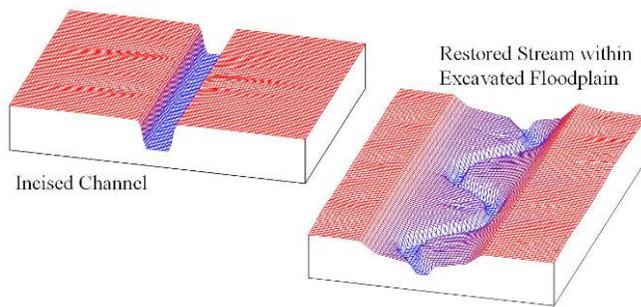
**FIG 13: Before and After Representations of a Priority Level 2 Stream Restoration**

On the other hand, the Priority Level 2 approach can be used to reduce flood elevations and provide additional storage, but costs associated with hauling earth material can be prohibitive, unless there is a location close to the project site.

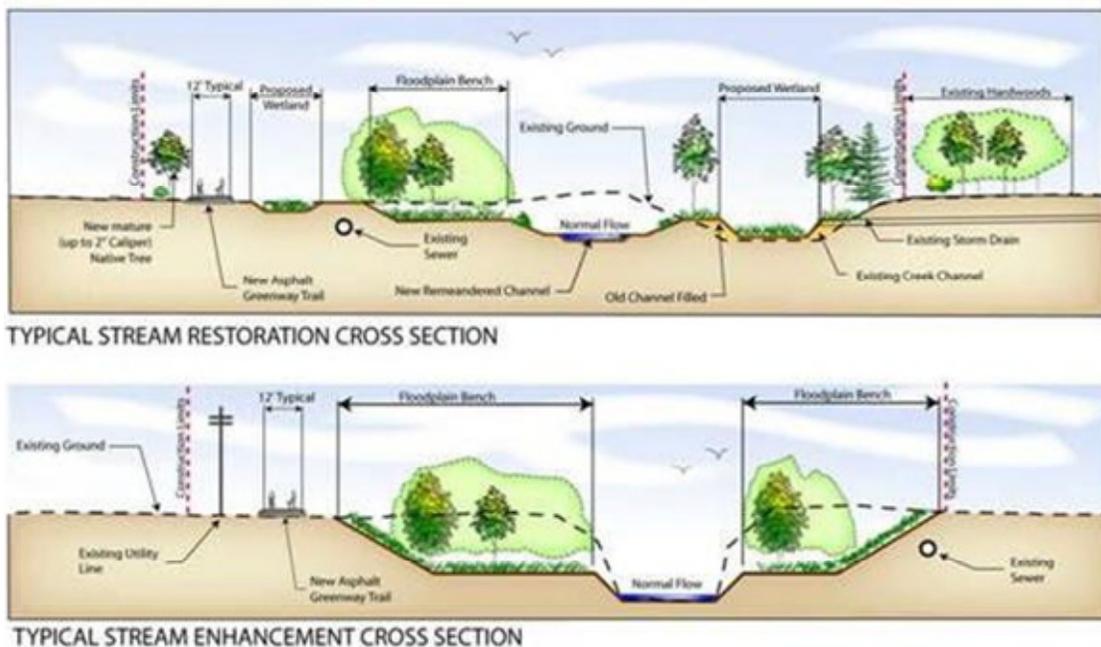
FIG 14: Stream Restoration and Enhancement Typical Cross Sections

Stream enhancement, in contrast to stream restoration, can typically be done without affecting the channel below the normal high water, which has a significant impact on the permitting requirements that might be attached to a project. As presented in the Project Concept Plans in the [Appendix](#), stream enhancement primarily consists of measures to halt or slow down the lateral instability of streams through the use of matting and vegetation. Minimal earthwork is anticipated, but floodplains may be excavated to provide better access and/or storage for higher flows.

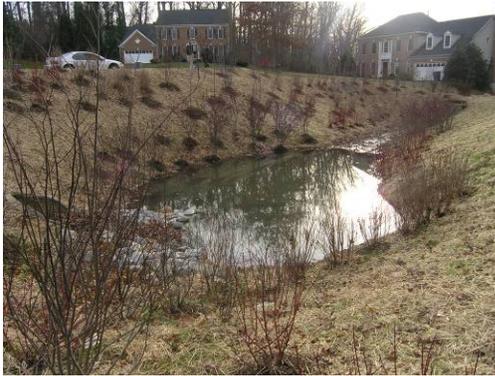
Pond retrofit projects, as the name suggest, are projects where existing ponds are modified to alter and improve their net benefit to the receiving system. In most cases, ponds are built with consideration only for the area draining to them, and are designed to meet pre-determined, regional performance goals. By considering the watershed dynamics both above and below the pond and the needs of the watershed, as a whole, ponds may be retrofitted to provide a more holistic benefit within the watershed.

**FIG 15:** Northern Virginia Pond Retrofit Shortly after Construction

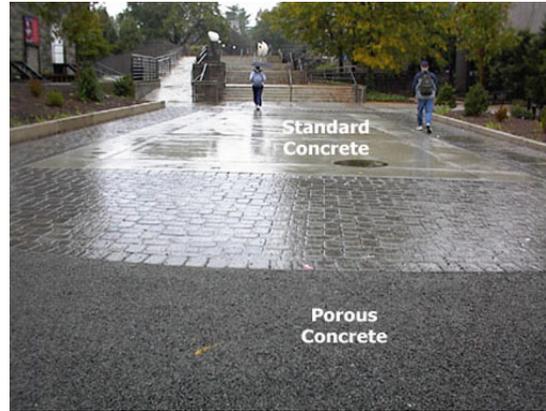
**FIG 16:** Side by Side Comparison of Standard Concrete and Porous Concrete at Villanova University

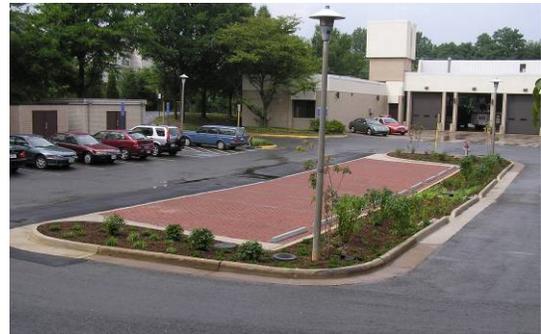
**FIG 17:** Northern Virginia Retrofit Using Porous Pavers and Conversion of a Parking Island to a Bio-Infiltration Facility

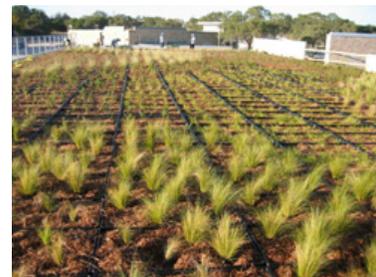
**FIG 18:** GREENGRID® is a Modular Green Roof System for Retrofit Applications

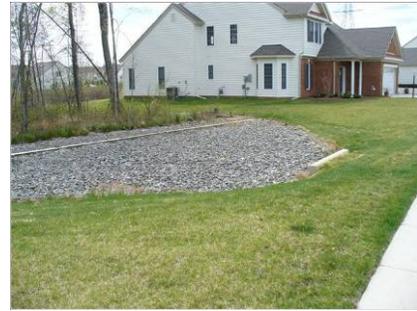
**FIG 19:** Henrico County has Shown Level Spreaders to be Very Effective at Eliminating Scour at Outfall Locations

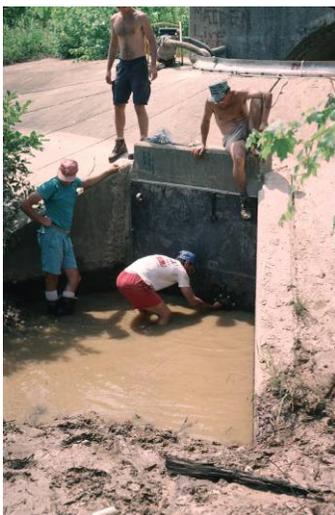
A culvert retrofit is a broad term to describe a number of hydraulic enhancements that can be fitted to a culvert to change the characteristics of how discharges are conveyed through the culvert. In most cases, the culvert under consideration was designed to convey drainage from one side of a road to the other. This means that, in many cases, VDOT or another transportation agency will have to approve any alteration to the infrastructure. If designed appropriately, the retrofit facility can significantly change the runoff characteristics without negatively affecting the culvert and/or roadway's functionality. Two primary concerns that transportation agencies raise regarding culvert retrofits is: 1) that the infrastructure must allow the design discharge to be conveyed without causing the roadway to overtop and 2) that water

**FIG 20:** Construction of the Dale Blvd Retrofit project

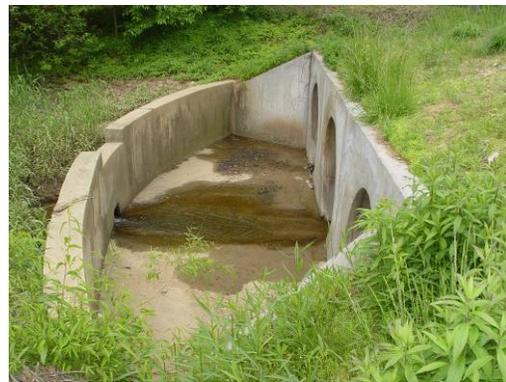
In the Powells Creek watershed, we have already concluded that dry detention storage should be prioritized wherever possible. This has the added benefit of addressing the concerns regarding ponding water against roadway embankments in that ponded water is lower on the toe of the slope and is temporary.

**FIG 21:** This Dry Pond Structure was Built in Conjunction with the Roadway Culverts on a Small Drainageway

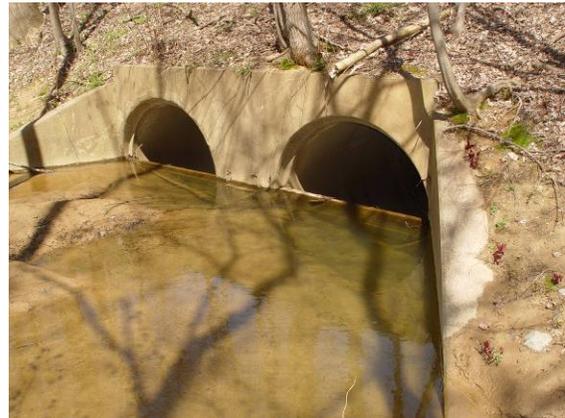
Sediment transport is a natural function of healthy streams. Creating obstacles to “healthy” sediment movement creates an imbalance in the stream system, resulting in a poorly functioning system. Assessing the sediment transport requirements of the stream in which the retrofit will be placed and making provisions for it to pass should be considered in the design of a retrofit. Barriers to the channel, and structural elements that are often associated with the creation of a wet storage area will block sediment and fish passage and may lead to excessive and costly maintenance needs.

**FIG 22:** Culvert Retrofit that Reduces Discharge Capacity, and does not accommodate sediment and animal passage.
