Quantico Creek Watershed Assessment Report

Prepared for:
Prince William County
Department of Public Works
Watershed Management Branch
5 County Complex Court, Suite 170
Prince William, Virginia 22192

Prepared by:
MACTEC Engineering and Consulting, Inc.
21740 Beaumeade Circle, Suite 150
Ashburn, Virginia 20147

April 2011

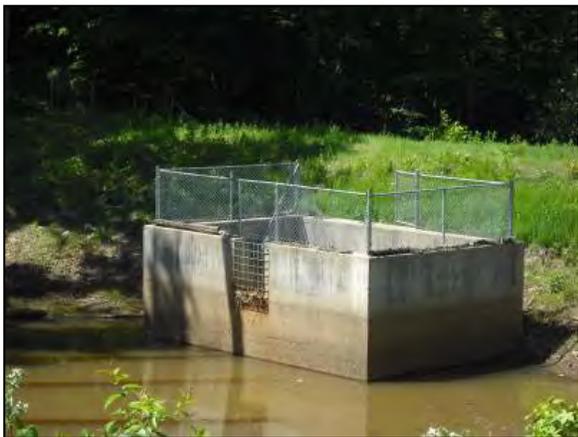
Figure 3-10: Existing Concrete Outlet Structure.

Basin Structures – The existing basin inlet(s), embankment, riser and outlet all present opportunities for retrofit to achieve more effective storage. Structure modifications can be a straight-forward and cost-effective approach to increase the basin’s detention volume and draw down time, at great benefit to receiving streams, water quality, and the vegetative community within the pond. Restricting the orifice on an outlet structure, for example, can extend the drawdown time and increase storage volume for smaller storm events, such as the “first flush” or water quality storm.

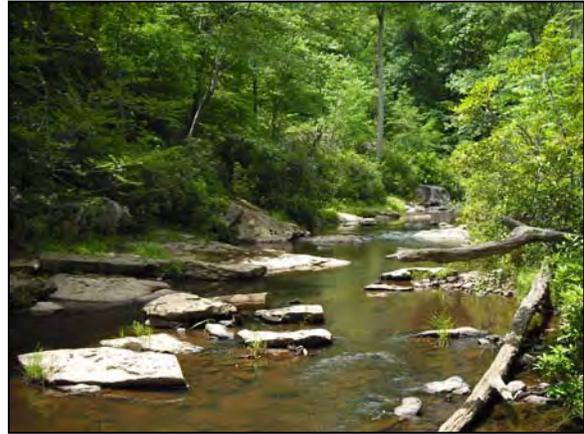
Figure 4-2: Relatively undisturbed reach of Basin 615, within Prince William Forest Park.

The main channel of the South Fork of Quantico Creek, flowing through the Park, is in nearly pristine condition, with little evidence of channel instability or bank erosion. Each of the RSAT parameters yielded scores in the *Excellent* or *Good* categories along the main stem. Reach 615-A begins at a marked transition in channel morphology, from the steeply-sloped, bedrock and boulder dominated reaches located immediately upstream, to a gentle, meandering channel composed of predominantly gravel and cobble substrate. Channel stability and scouring/deposition scores remain high (“good” category), with a slight increase in bank scouring, occurring opposite of gravel point bars. In-stream and riparian habitat are in excellent condition along this reach, corresponding with the rich diversity and large quantities of macroinvertebrates.

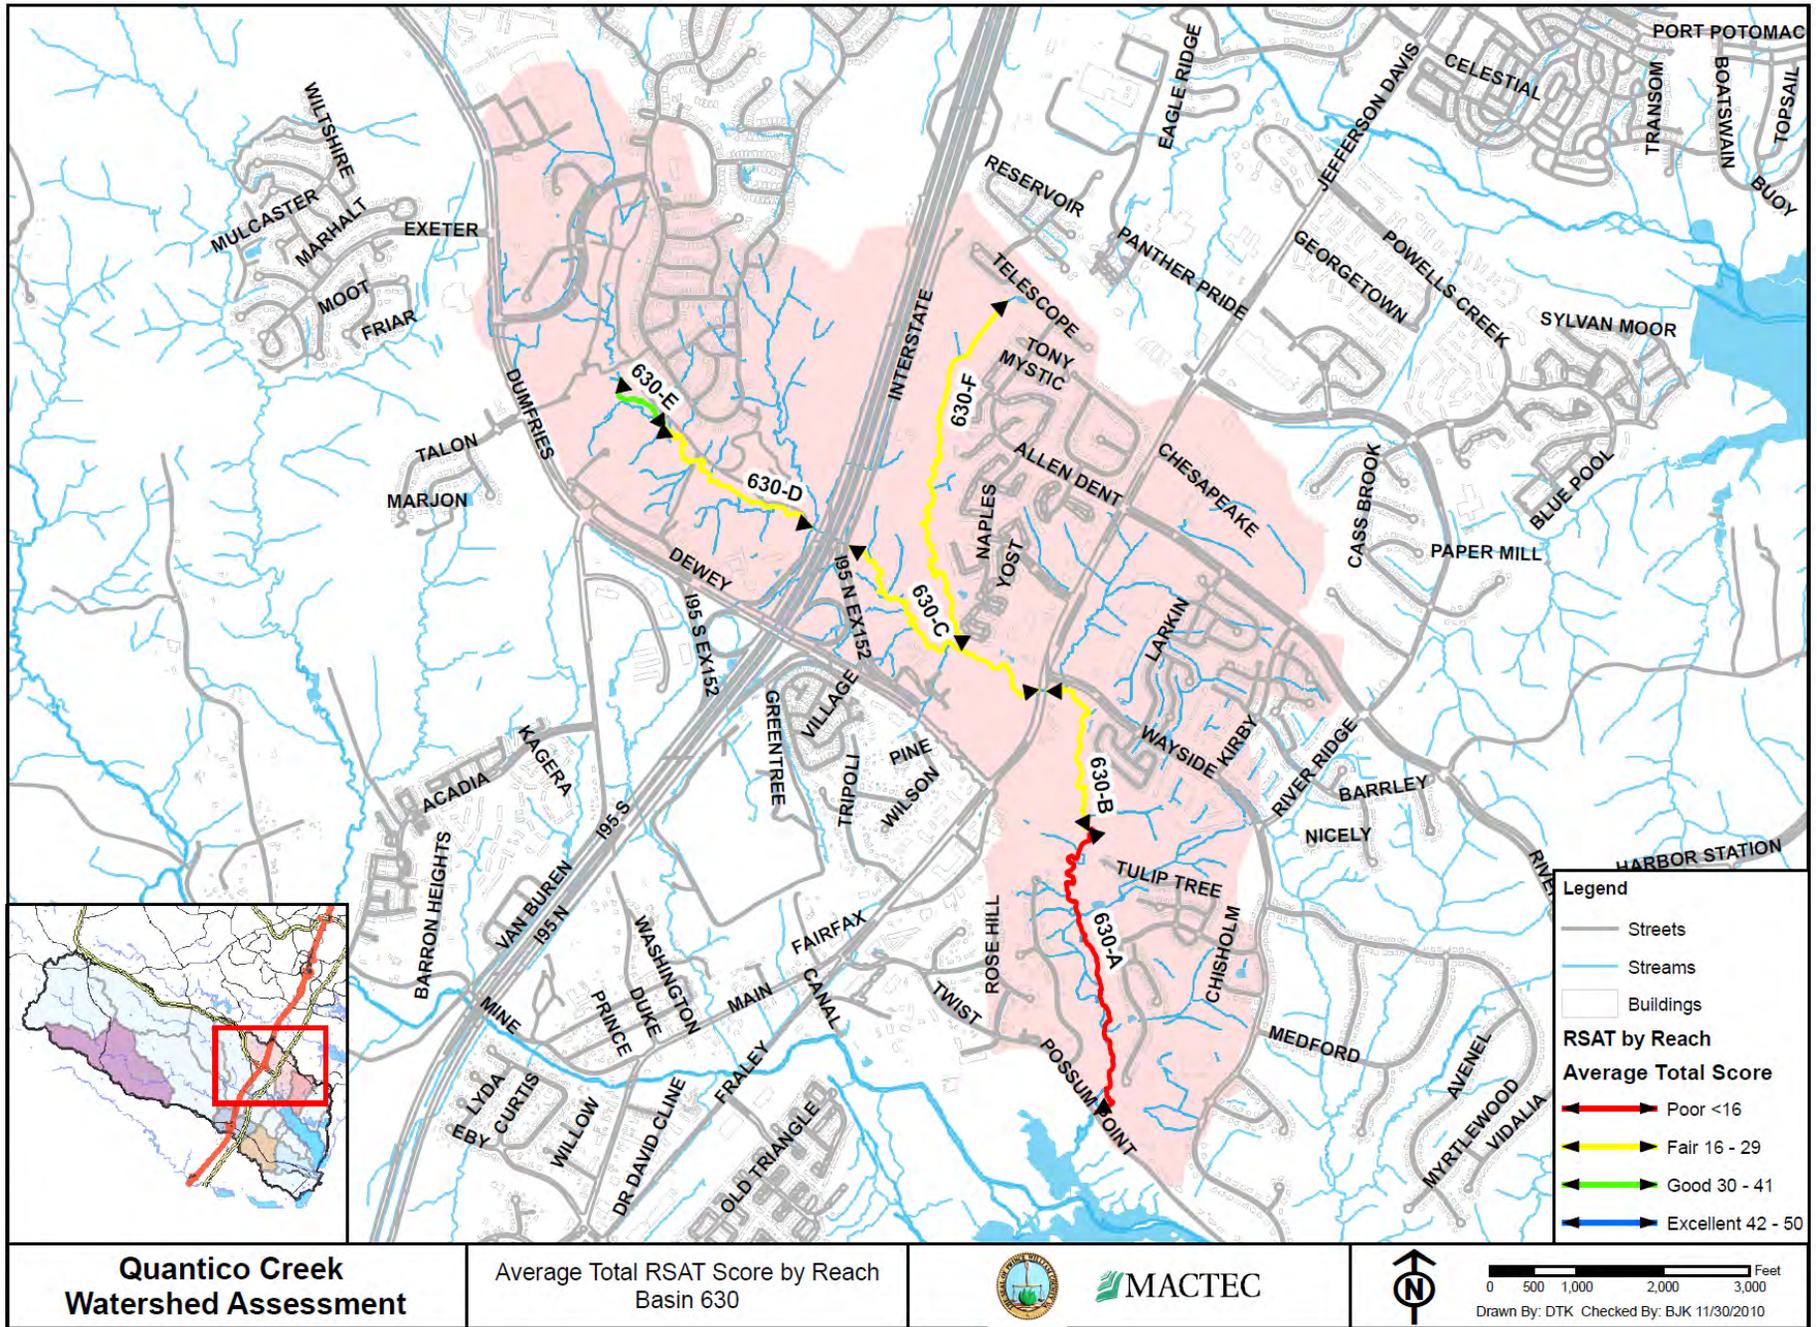
Figure 4-9: RSAT Average Total Score by Reach for Basin 630, Dewey's Creek.

- 630-D (11818042.79 - 6898816.70 to 11819766.46 - 6897648.47): Channel incision and widening has resulted in systemic streambank erosion, and exposure of a previously buried sewer line parallel to the stream, south of Four Seasons Drive to the culvert at Interstate I-95.
 - Illegal dumping of concrete rubble, tires and other debris (via an access road from Old Stage Road) has created and impoundment in the channel, interfering with the flow of water and sediment.
- 630-F (11822018.15 - 6900262.19 to 11821486.97 - 6896226.01): Moderate channel incision has been slowed by woody debris jams (that act as natural *de facto* grade control) and bank stabilization provided by a wide riparian forest buffer, from the upstream end of the reach at Telescope Lane, to the confluence with Reach 630-C near Dry Powder Circle.

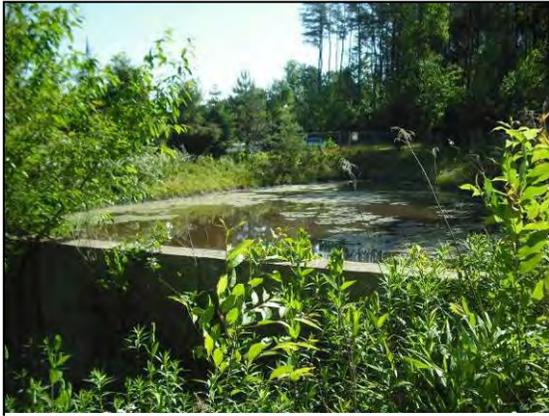
Figure 4-32: A single-stage, concrete weir overflow structure at FAC-5473.

- FAC-5473 (11,785,626.94 - 6915704.77): The existing wet pond, located behind the Reconciliation Community Church (near the intersection of Bristow and Joplin Roads), has a single-stage, concrete weir overflow structure that appears to be ineffective at controlling varied flow events, including smaller, more frequent *water quality* and *channel protection* storm events. In addition, the pond appears to have nutrient and eutrophication problems, as evidenced by excessive algae growth. The pond lacks a forebay that could help alleviate sediment and nutrient loading issues.

- Figure 5-7:** Example of pond forebay, designed for capture of sediment and debris.
- FAC-5473: The pond appears to have nutrient and eutrophication problems, as evidenced by excessive algae growth. We recommend the addition of a forebay at the main entry point to the pond to alleviate sediment and nutrient loading issues. Furthermore, the existing concrete weir overflow structure appears to be ineffective at controlling varied flow events. While the existing structure can remain in place, we recommend retrofitting the outfall with a multi-stage riser.

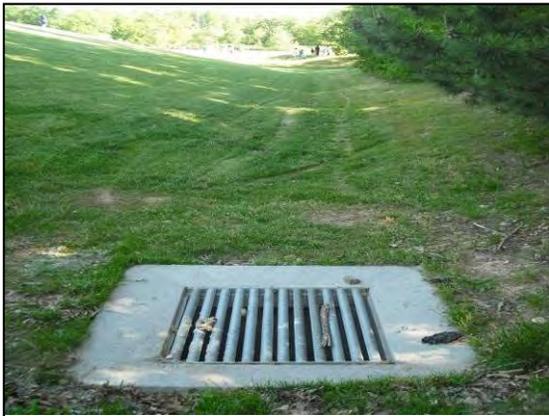
Figure 4-33: A grated inlet structure at the downstream end of the shallow swale,

- FAC-558 (11,799,086.01 - 6,912,385.58): Located in the Ashland Subdivision, adjacent to Ashland Elementary School, the shallow stormwater swale, appears to provide adequate stormwater conveyance to an enclosed system (via grated inlet structures). Overland flow makes its way into an extended detention basin to the north of the school, parallel to Tinkling Springs Court. The basin is well vegetated and appears to provide adequate storage. However, the stormwater swales provide limited storage, infiltration, and treatment capacity.

- FAC-558: While the existing stormwater swales provide limited storage, infiltration, and treatment capacity, they can be retrofitted to perform as infiltration features by excavating the swale bottom (to a minimum depth of 3ft) and constructing an infiltration trench with gravel backfill and amended planting substrate. Add low rock check dams to encourage storage and infiltration. Revegetate the swale with native riparian species to provide additional hydraulic roughness.

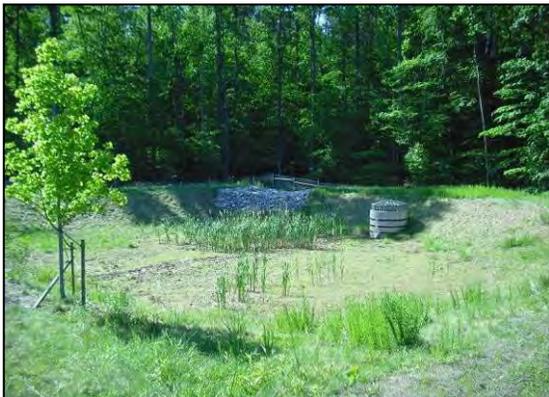
Figure 4-34: Dry basin lacking internal structure, microtopography and vegetation.

- FAC Unknown: The existing dry basin lacks internal structure, microtopography, and vegetation that would extend the flow path and increase the residency time of stormwater runoff from the adjacent roadway. Regrade the bottom of the basin to lengthen the flow path from inlet to outlet, and revegetate with native riparian species to facilitate pollutant attenuation.
- FAC-5379: The dry basin is located adjacent to Dumfries Road, near the intersection with Hide Away Drive. The basin lacks internal structure or microtopography, and vegetation that would otherwise extend the flow path, increase residency time, and facilitate attenuation of pollutants.

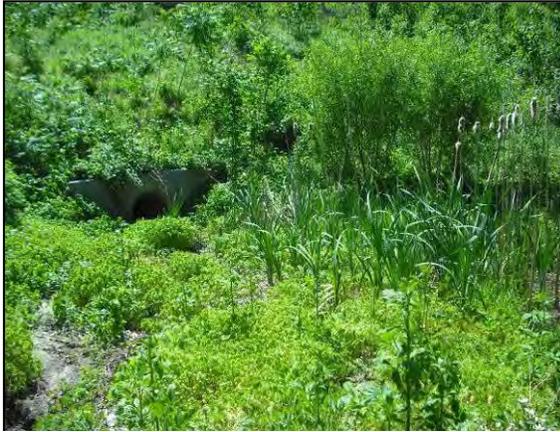
Figure 4-44: Extended detention basin with dense vegetative growth, FAC-505.

- FAC-505: The extended detention basin is densely vegetated, but could benefit from additional internal structure, berms or microtopography. Add berms along the detention basin bottom to lengthen the flow path from inlet to outlet, and revegetate within the area of disturbance with native wetland and riparian species.

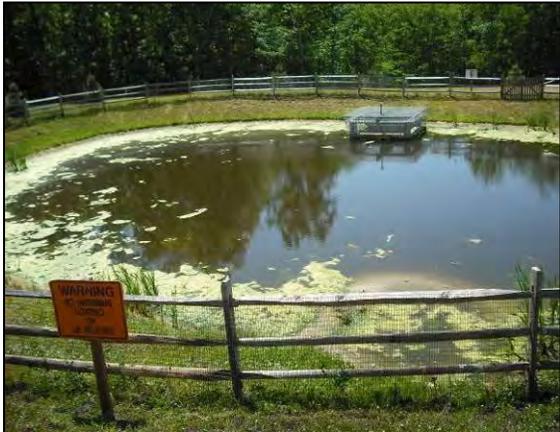
Figure 4-45: Existing wet pond, lacking forebay and native vegetation, FAC-Unknown.

- FAC Unknown (11,826,322.66 - 6,889,258.44): The existing wet pond is located in a newly constructed subdivision, at the intersection of Myrtlewood Drive and Crystal Downs Terrace. The pond lacks a forebay and native wetland or riparian vegetation that could alleviate the siltation problem, already observed at the inflow to the pond.

- FAC-Unknown (9999): The existing wet pond lacks a forebay and native wetland vegetation that could alleviate siltation problems. Construct a forebay at the main entry point to the pond and revegetate with native wetland species.
- FAC-9025: The existing wet pond is the largest of the basins included in the assessment, and appears to have adequate storage for runoff from the surrounding residential area. While the pond is well-designed, it could benefit from the addition of native wetland vegetation around the perimeter of the pond to increase pollutant attenuation capability and provide habitat.
